In-Vitro Evaluation of Microleakage of Class II Cavities Restored with Bulk-Fill Flowable Composite

Background and Aim: Composite placement poses many challenges, especially in the gingival floor with dentinal margins. Microleakage is one of the factors affecting the longevity of dental restorations. We aimed to compare the microleakage of cavities filled with bulk-fill composite at enamel and dentinal margins.

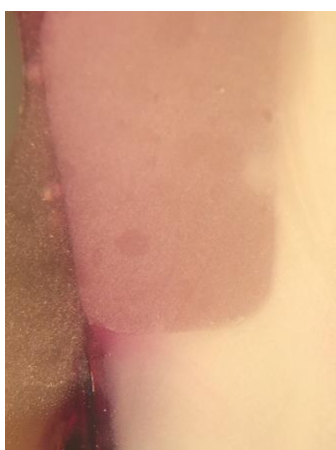
Figure 2. Scanning electron microscope (SEM) image ($\times 40$); score 1 in the gingival margin

using a double-blade diamond disc with a 0.3-mm thickness under water coolant. The sections were then evaluated under a stereomicroscope (Nikon, SMZ 800, Tokyo, Japan) at ×40 magnification (Figures 1 to 3). The enamel and dentinal margins of both halves of each tooth were evaluated by two blind observers. Microleakage was evaluated according to the following criteria [10]:

1. No evidence of dye penetration.
2. Dye penetration along the occlusal/gingival wall to less than half of the cavity depth.
3. Dye penetration along the occlusal/gingival wall to more than half of the cavity depth but not extending to the axial wall.
4. Dye penetration along the occlusal/gingival wall to the full cavity depth, extending to the axial wall.

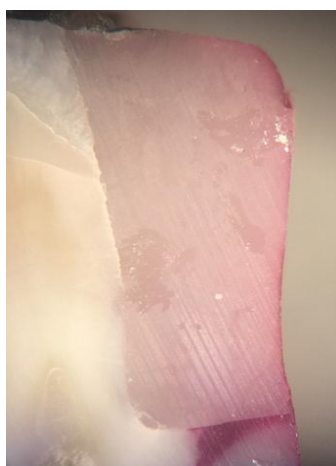
Figure 3. Scanning electron microscope (SEM) image ($\times 40$); score 3 in the gingival margin
