Original Article

Contamination of Dental Scaler Waterlines with Legionella Pneumophila, Pseudomonas Aeruginosa and Gram Positive Cocci

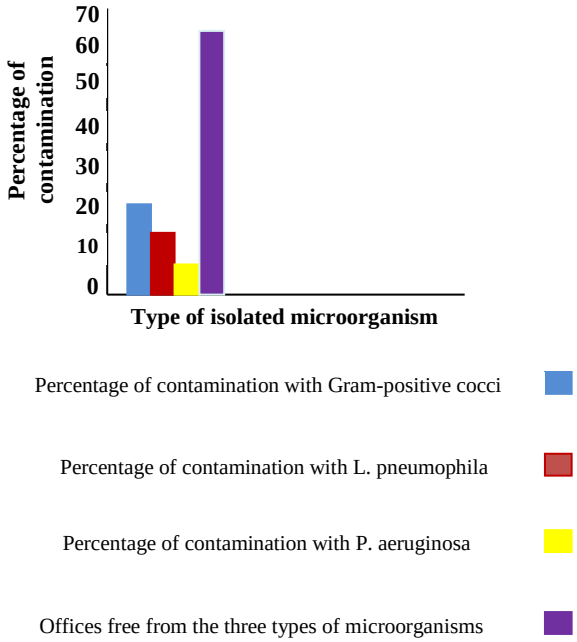
In all 50 dental offices under study, the control samples from tap water were free from microorganisms; 32 of the test specimens were negative for L. pneumophila, Gram-positive cocci and S. aeruginosa (Diagram 1). However, in 18 offices, dental unit water samples tested positive for these three bacteria (Table 1).

Diagram 1. Percentage of contaminated and contamination-free offices in terms of the three understudy bacteria
